# **Selected Images of the Effects of the October 15, 2006, Kīholo Bay-Māhukona, Hawai‘i, Earthquakes and Recovery Efforts**

Data Series 506

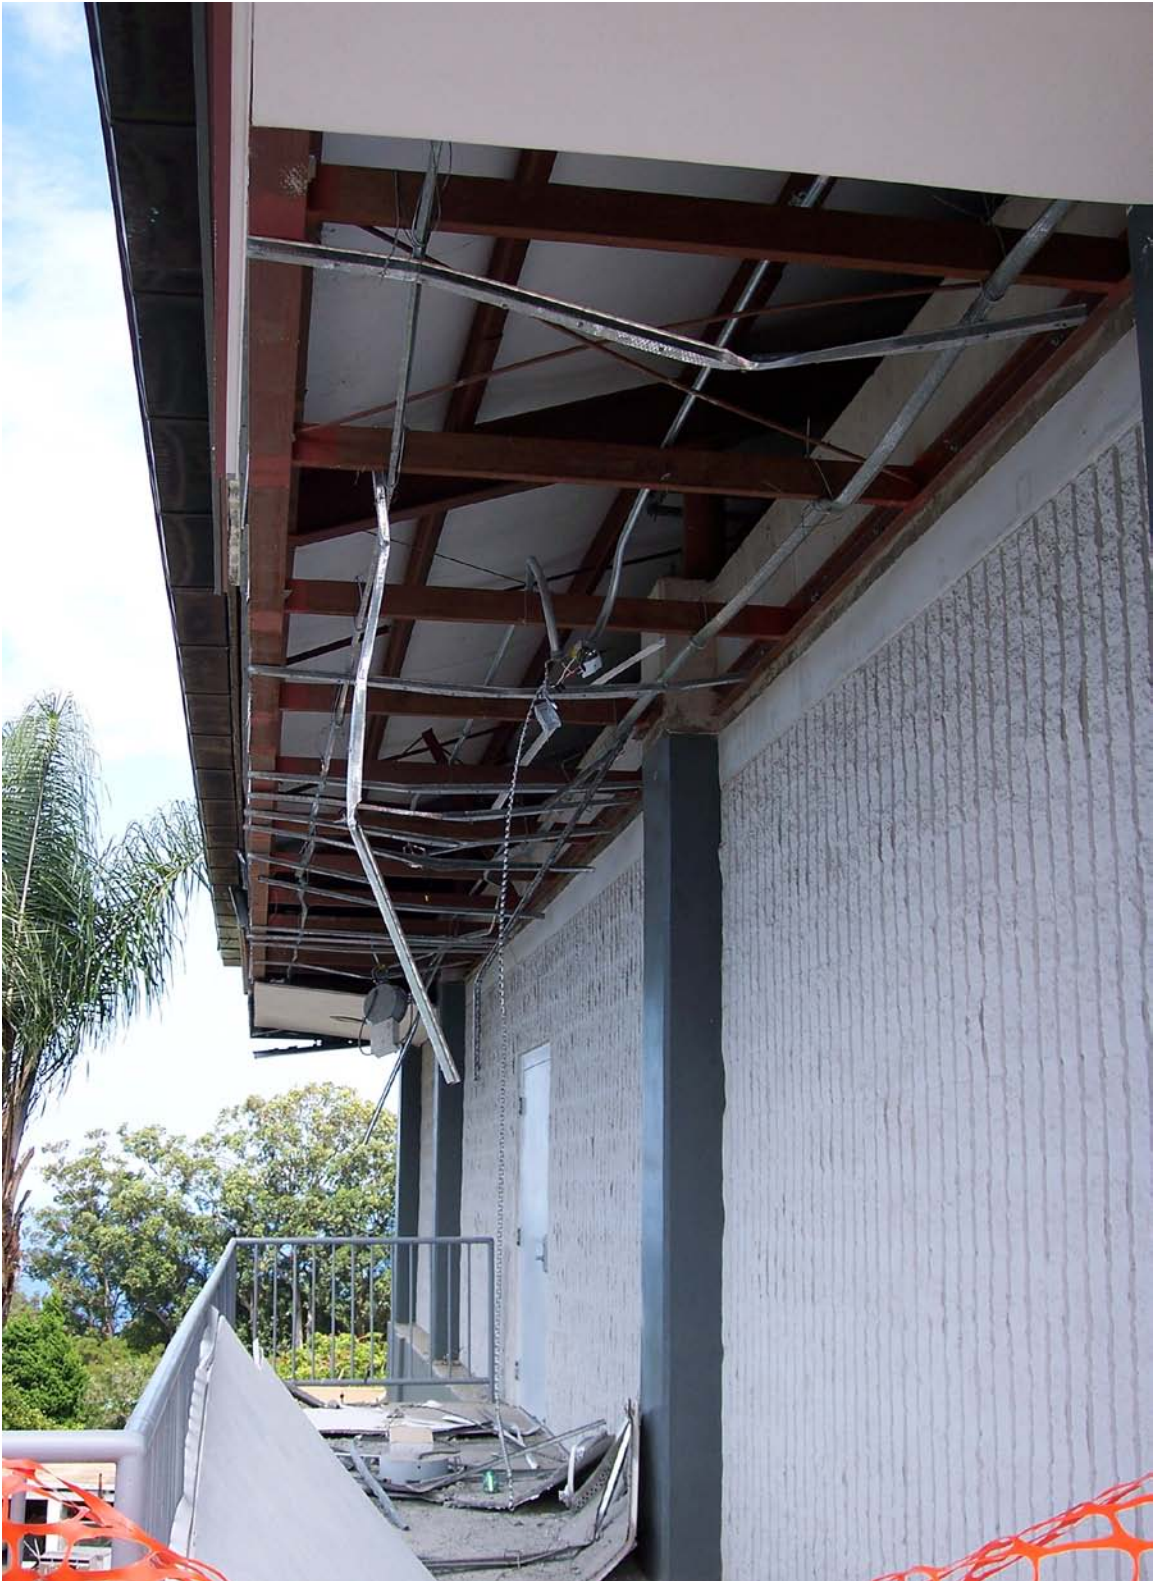
9.4. Side view (from the southwest) of the damaged exterior stucco ceiling tiles under the eaves, showing roof frame still intact (view to the northeast). USGS photo by T.J. Takahashi, 10/20/2006 (tjt1334).

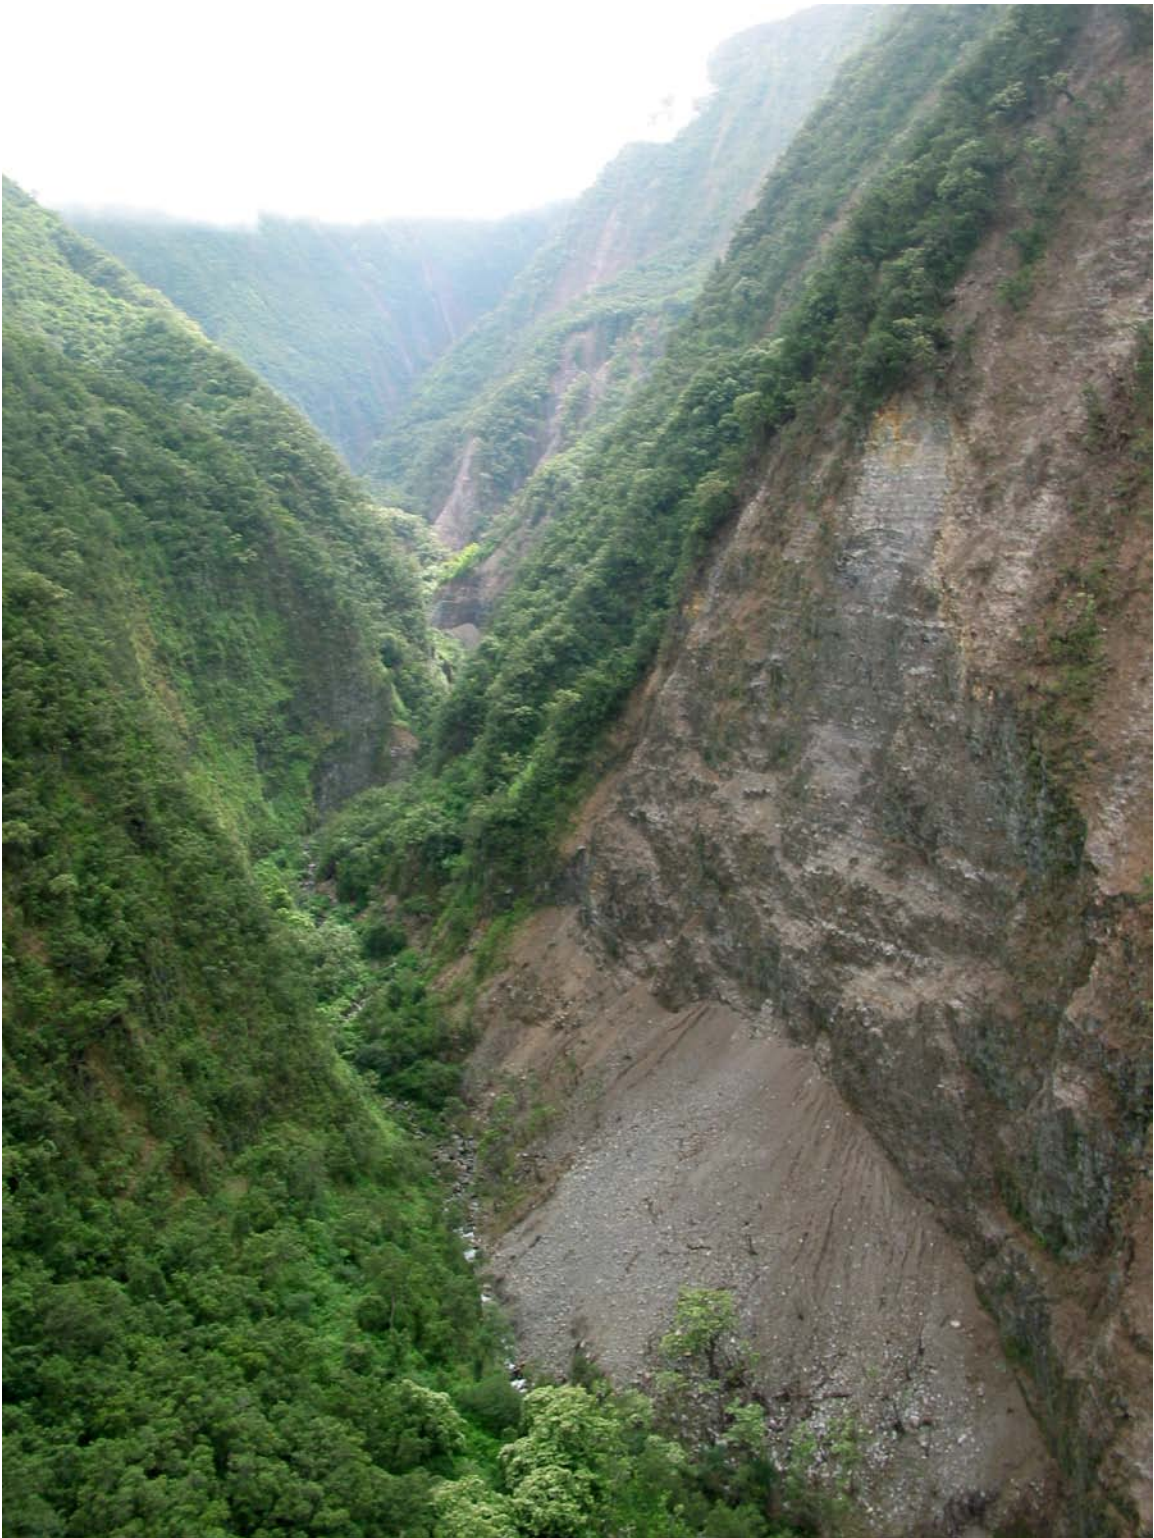
18.7. Aerial view of the large debris pile at the base of a rock slide in the West Branch of Honokāne Nui Valley (view to the south). USGS photo by J.P. Kauahikaua, 11/8/2006 (jpk5975).

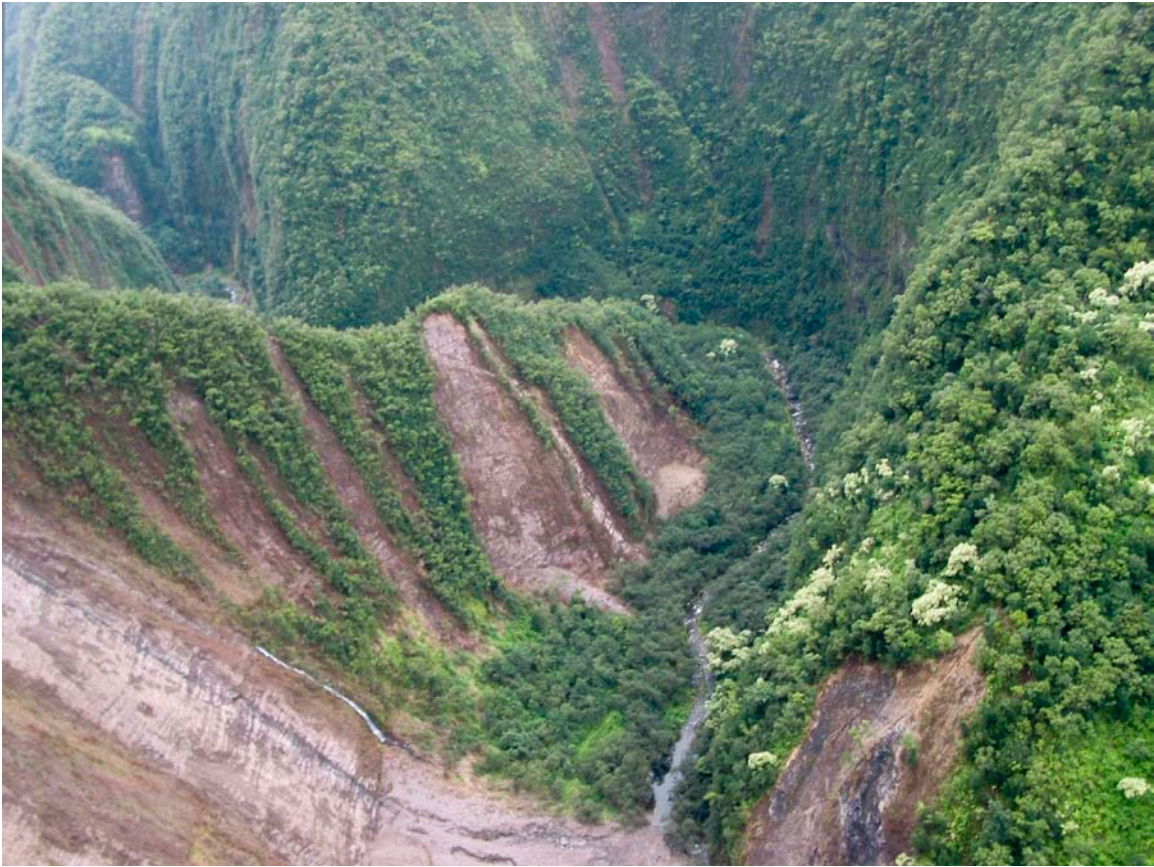
18.13. Aerial view of the stream and rock-fall scars on the eastern wall, about .74 km (~.46 mi) south of the Boy Scout Camp, in the East Branch of Honokāne Nui Valley (view to the south-southeast). USGS photo by J.P. Kauahikaua, 11/8/2006 (jpk5990).

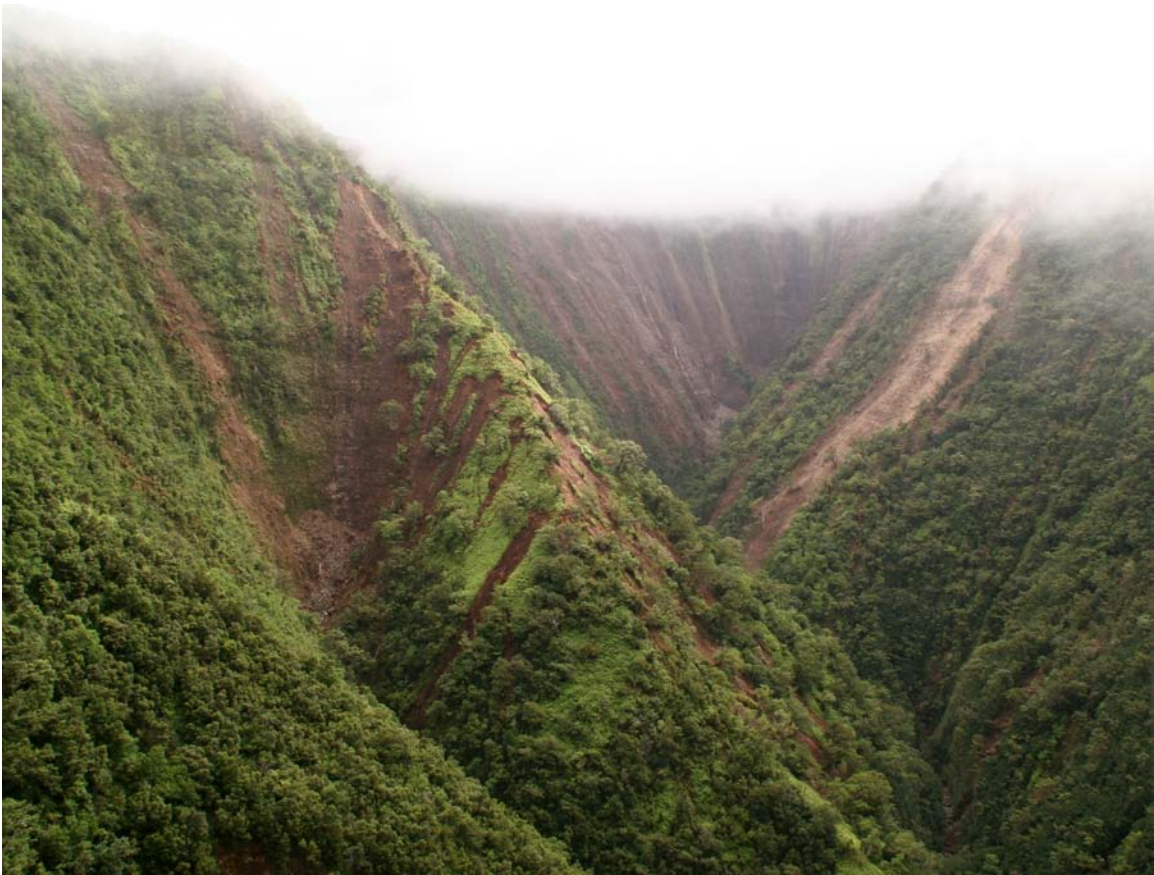
19.8. Close-up aerial view of rock-slide damage on the north side of the knife-like ridge in Pololū Valley (see photos 19.6 (elh1247) and 19.7 (rwj216); view to the south-southwest). USGS photo by E.L. Harp, 11/8/2006 (elh1245).

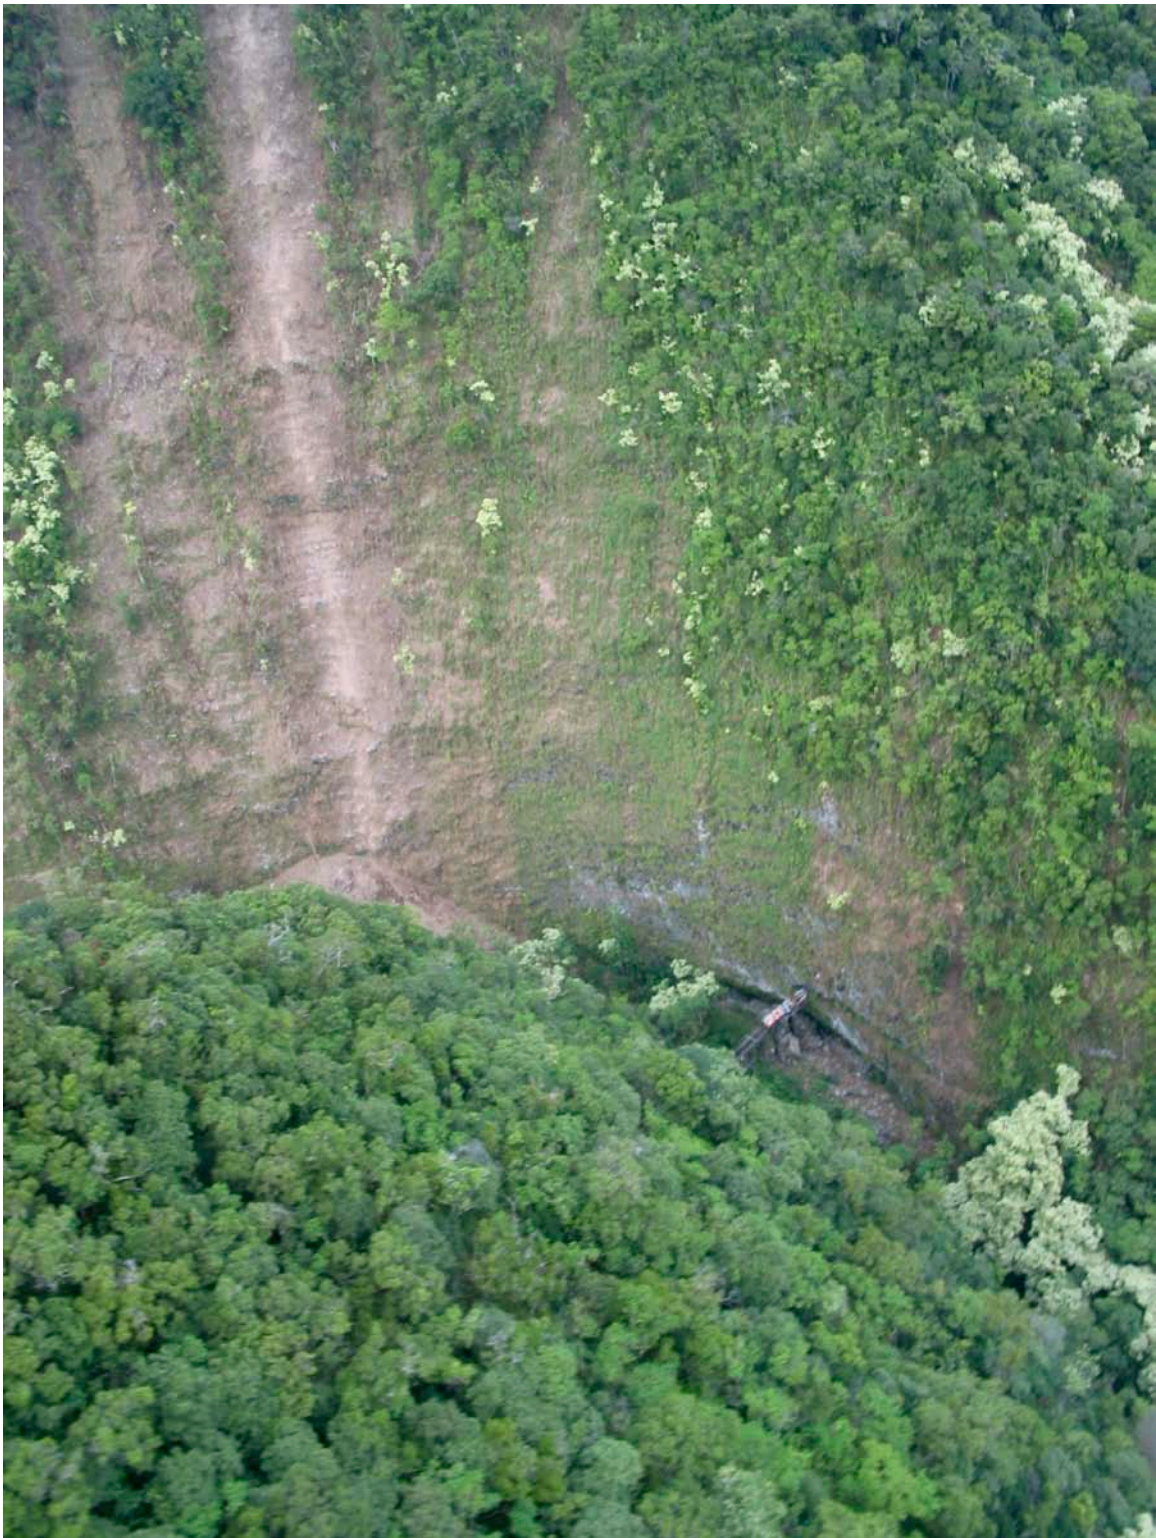
19.10. Aerial view of debris and rock falls along a valley wall near an irrigation flume section in Pololū Valley (view to the west-northwest). USGS photo by J.P. Kauahikaua, 11/8/2006 (jpk6025).

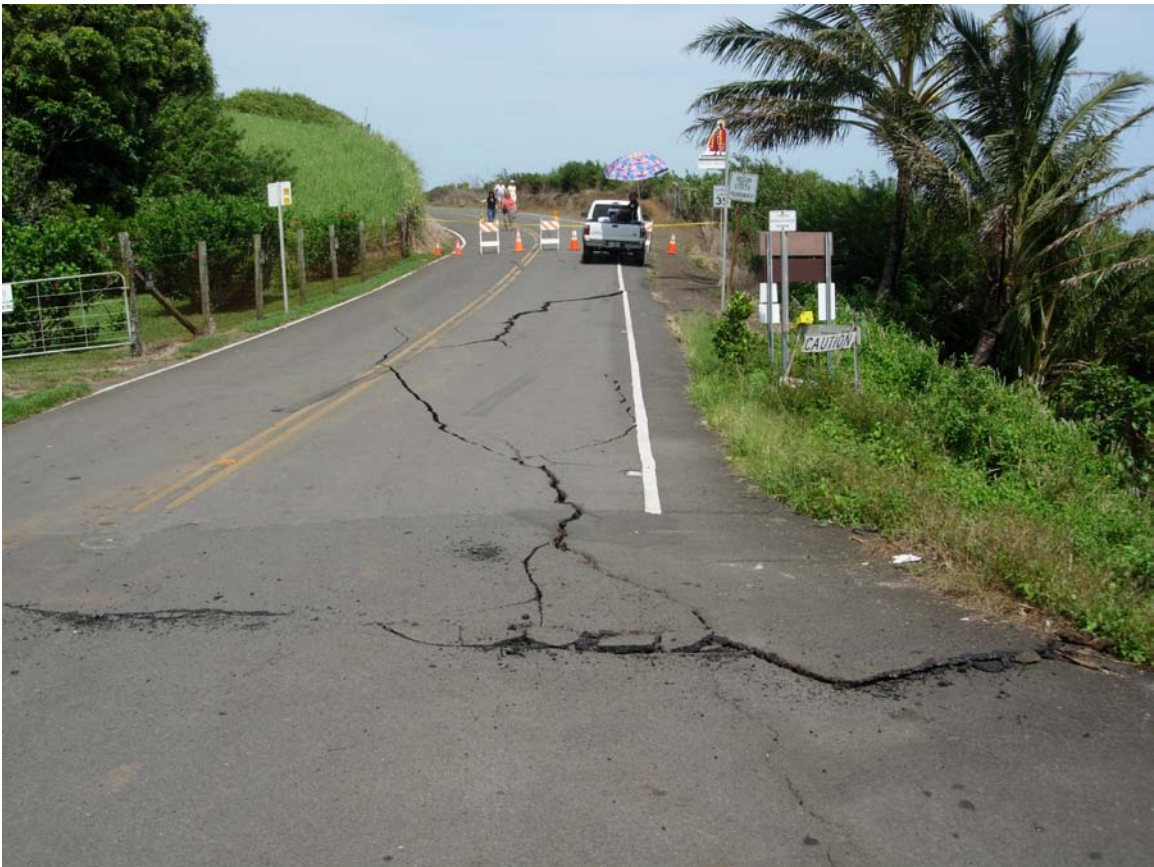
19.18. Overview of cracks in Niuli‘i-Hāwī Road (Hwy 270), from the Lookout at the end of the road (view to the northwest). USGS photo by M.P. Poland, 10/19/2006 (mpp004).

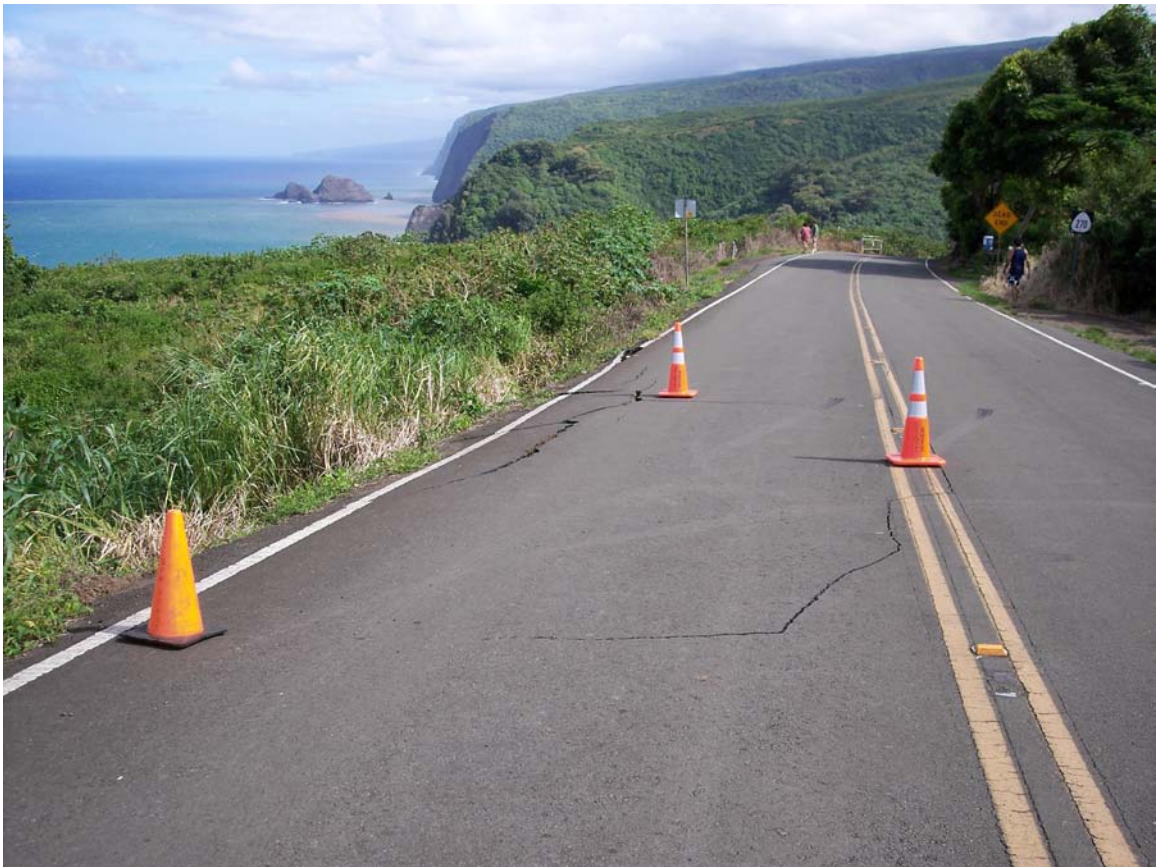
19.20. View of cracks in the asphalt pavement of Niuli‘i-Hāwī Road (Highway 270) to Pololū Valley Lookout. Rock-fall debris from the sea cliffs color the water (view to the southeast). USGS photo by T.J. Takahashi, 10/21/2006 (tjt1485).

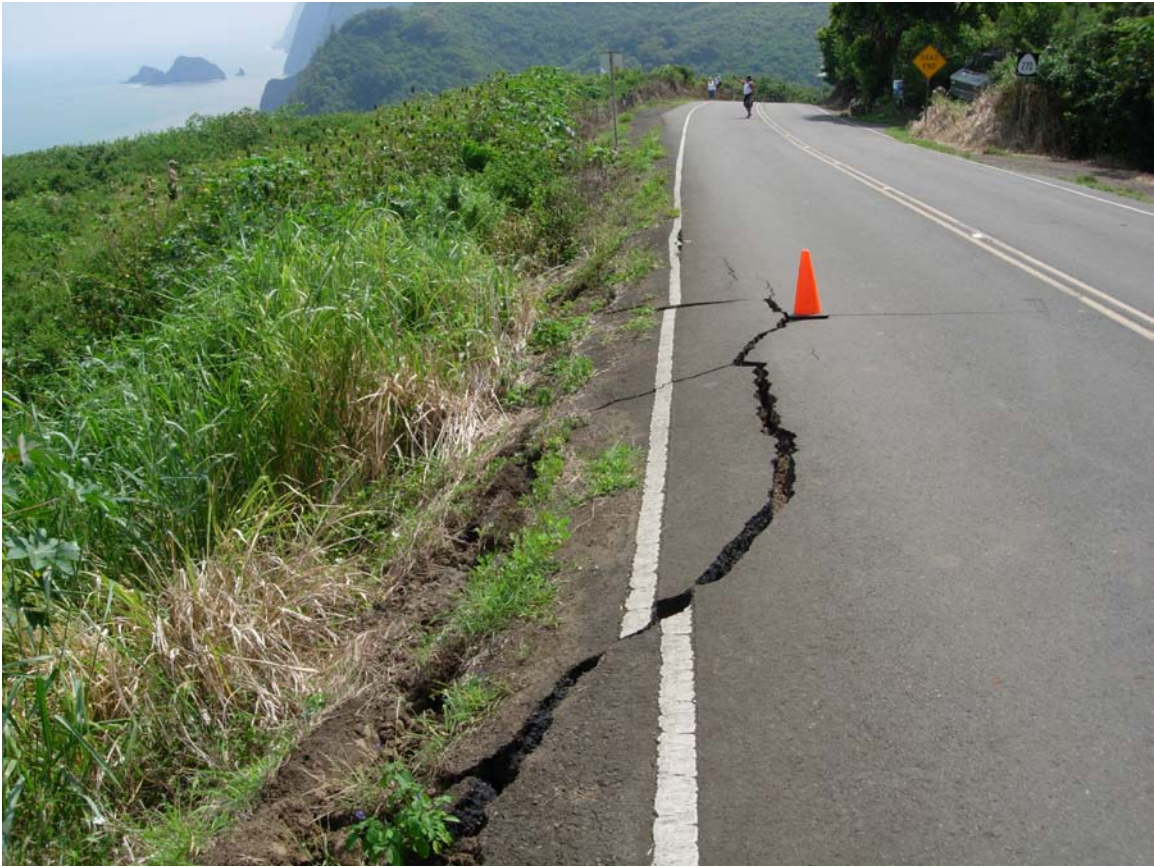
19.21. View of failure of the shoulder that resulted in cracks 2–3 cm wide (~1 in.) in the asphalt pavement of Niuli'i-Hāwī Road (view to the southeast). USGS photo by M.P. Poland, 10/19/2006 (mpp014).

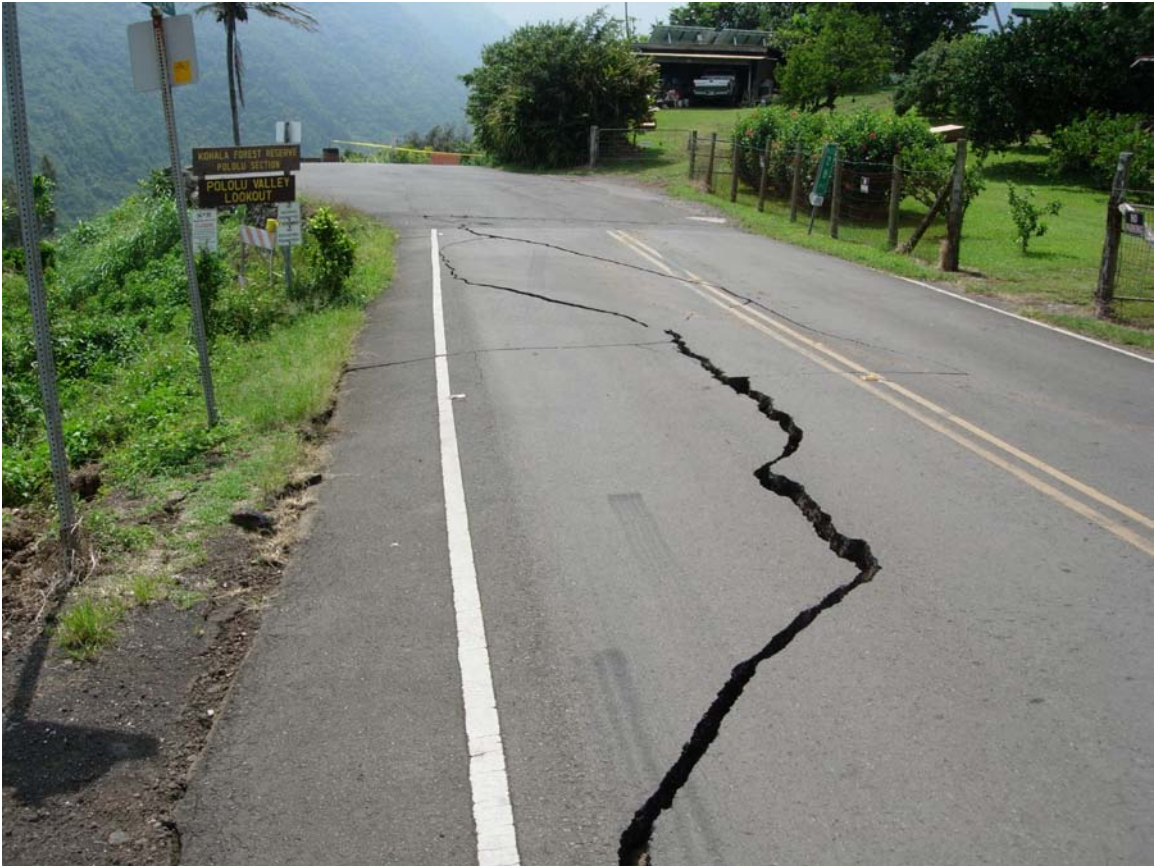
19.22. View of large cracks, 2–3 cm wide (~1 in.), in Niuli‘i-Hāwī Road near the Pololū Valley Lookout (view to the south). USGS photo by M.P. Poland, 10/19/2006 (mpp003).

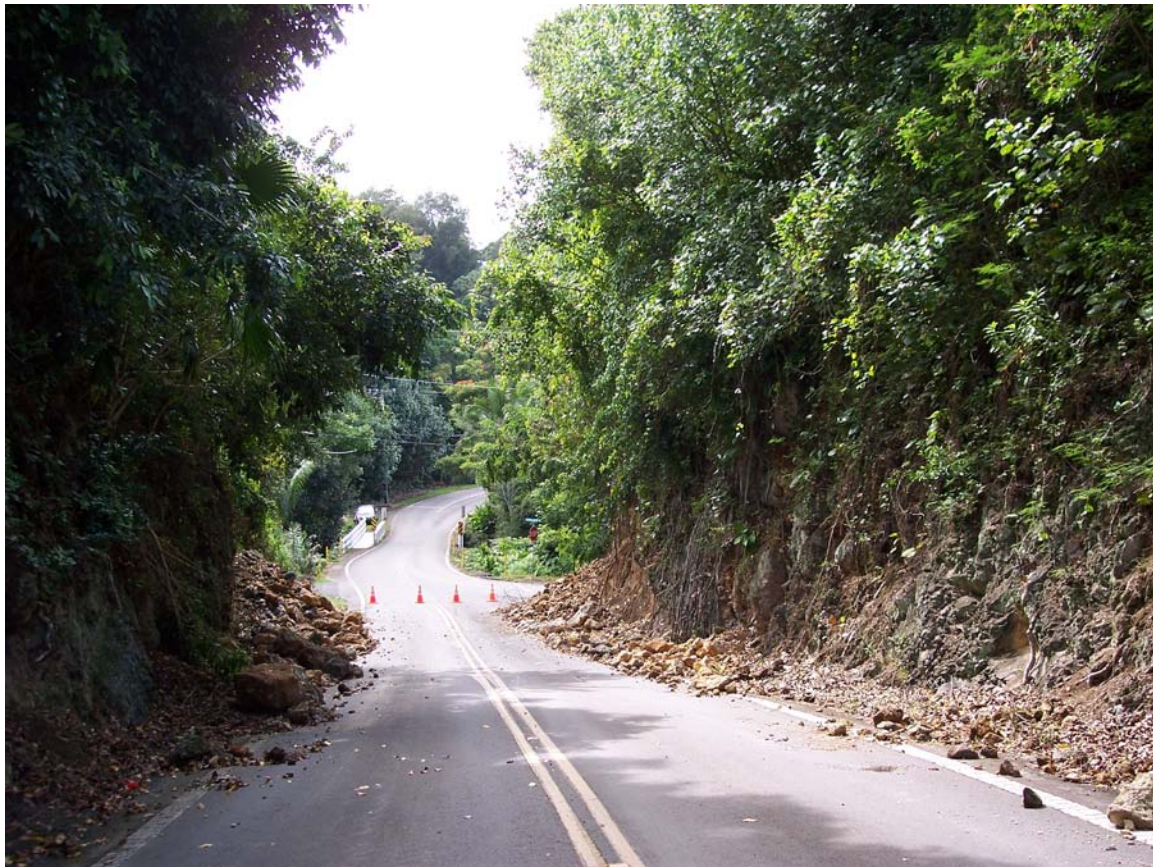
20.1. View of the rock-fall debris just past the intersection of Kēōkea Park Road (driving from Pololū Valley Lookout) and the Waikani Gulch one-lane bridge (view to the west-southwest). USGS photo by T.J. Takahashi, 10/21/2006 (tjt1513).

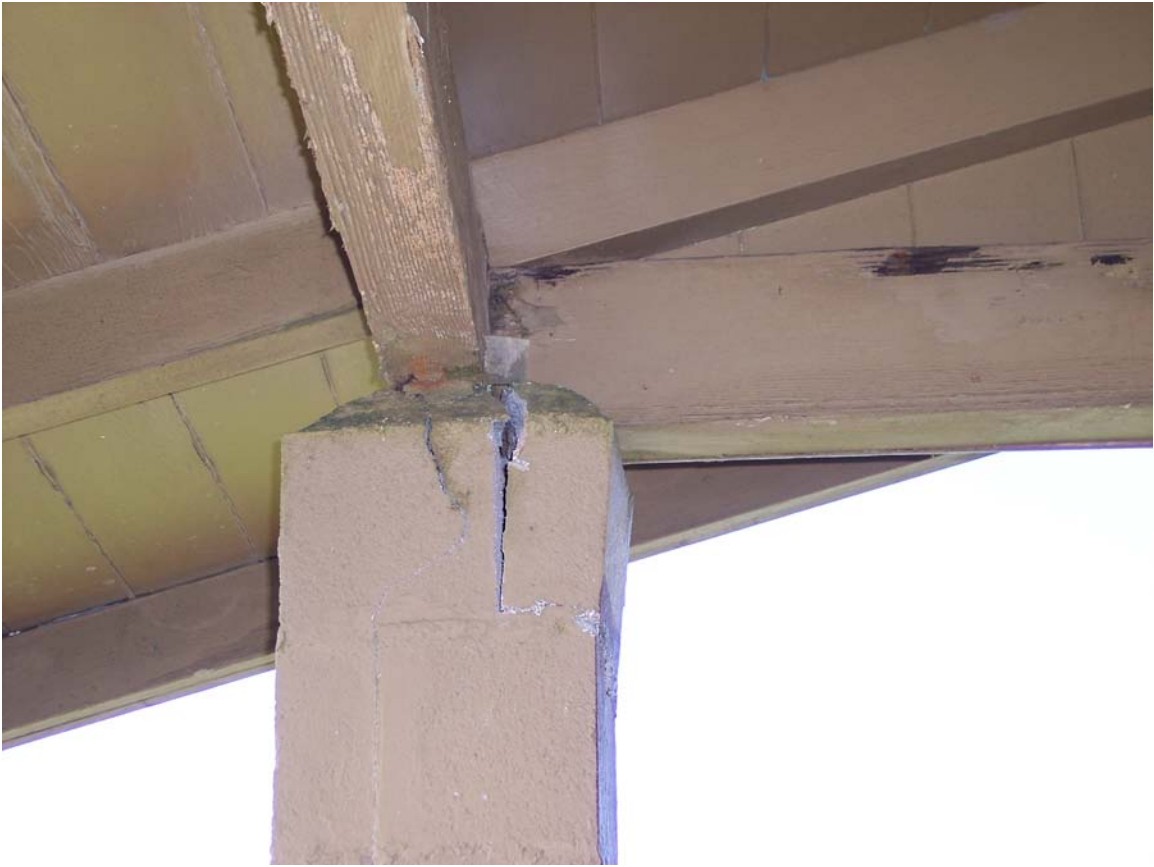
21.8. View of cracks in the concrete post supporting the roof beam of the gazebo (view to the north-northwest). USGS photo by T.J. Takahashi, 10/21/2006 (tjt1454).

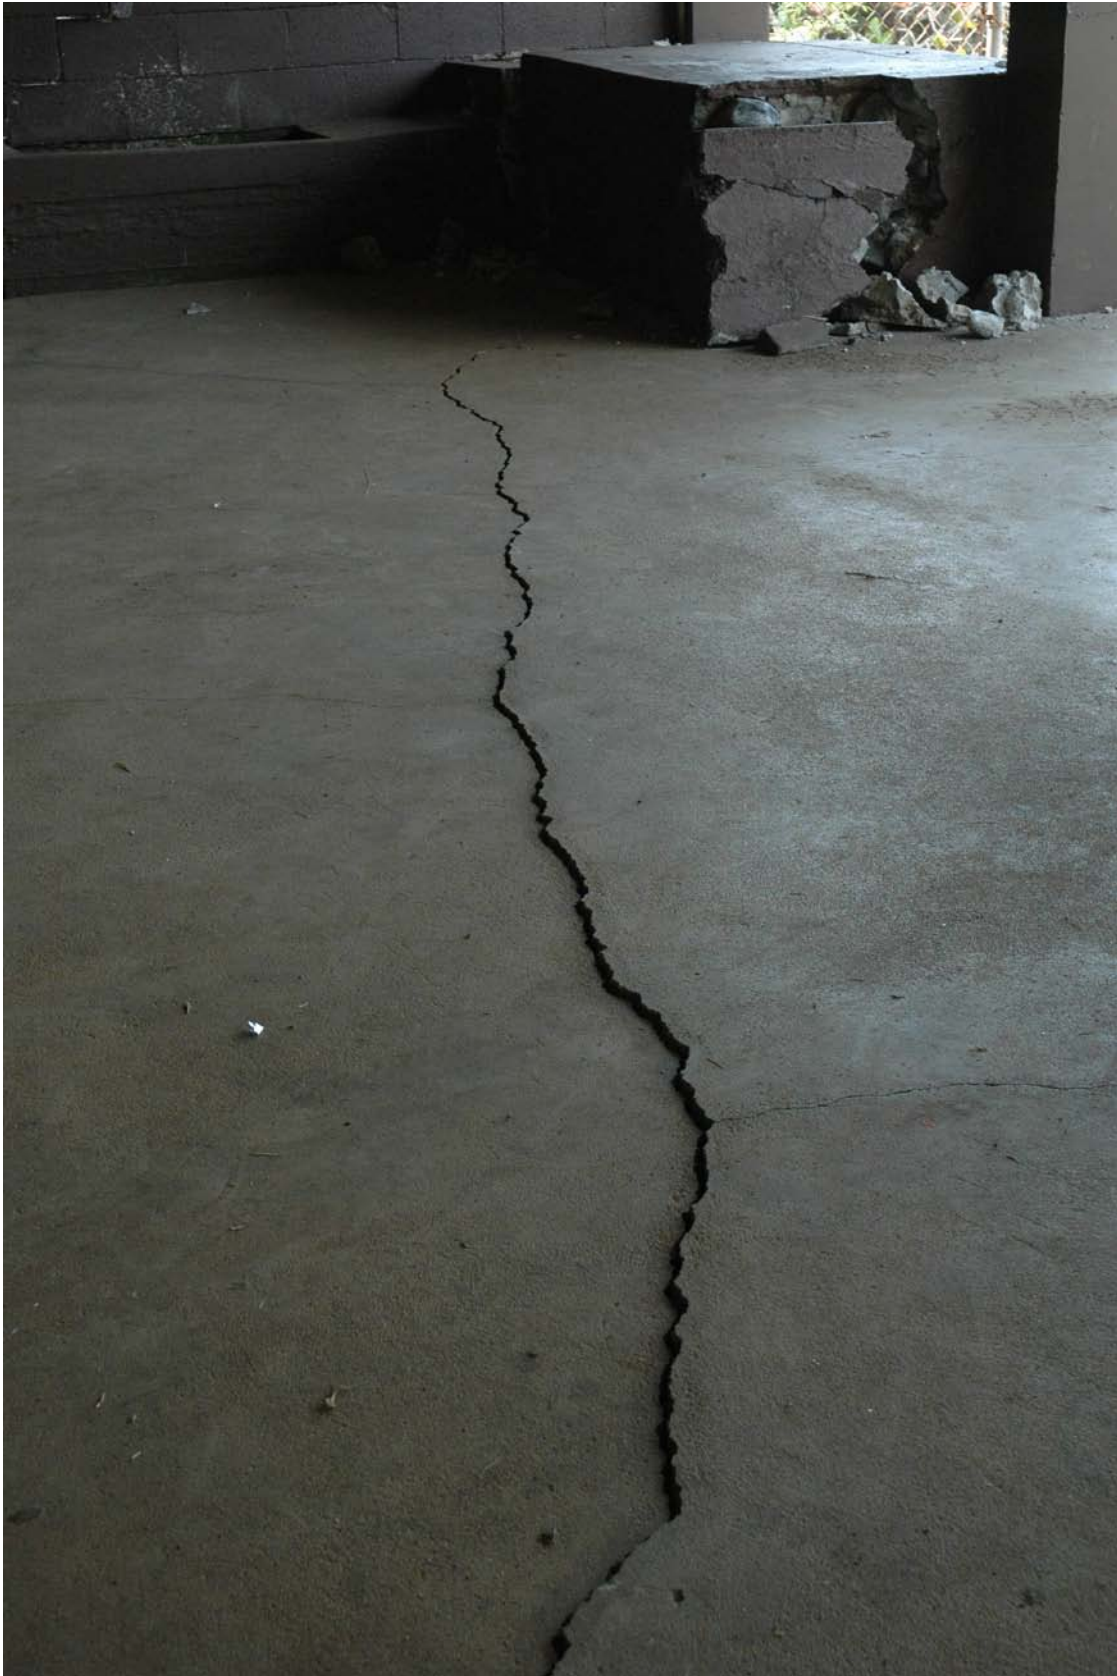
21.13. View of a large crack in the concrete foundation and cracks in the wall of the pavilion (view to the north-northwest). CSAV photo by D.A. Whilldin, 10/19/2006 (daw034).

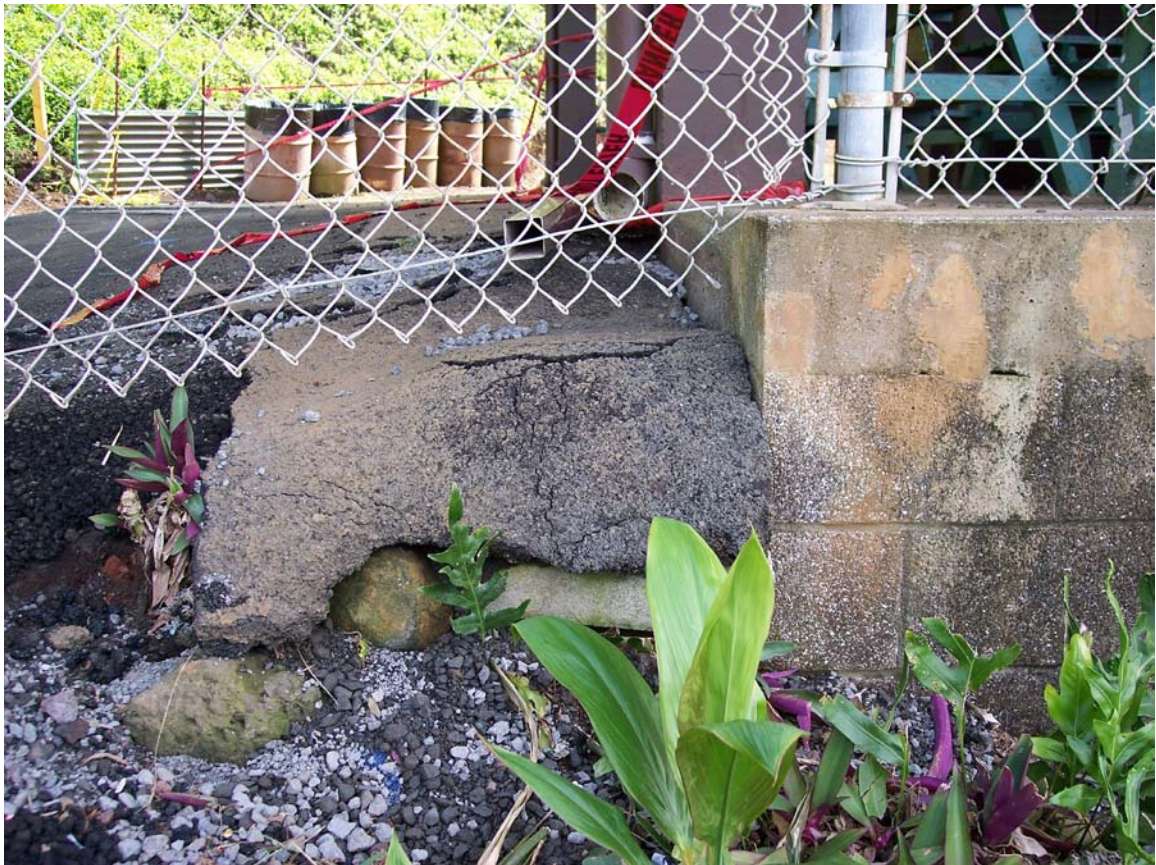
21.15. View of cracking and slumping of asphalt around the pavilion (view to the south-southeast). USGS photo by T.J. Takahashi, 10/21/2006 (tjt1464).

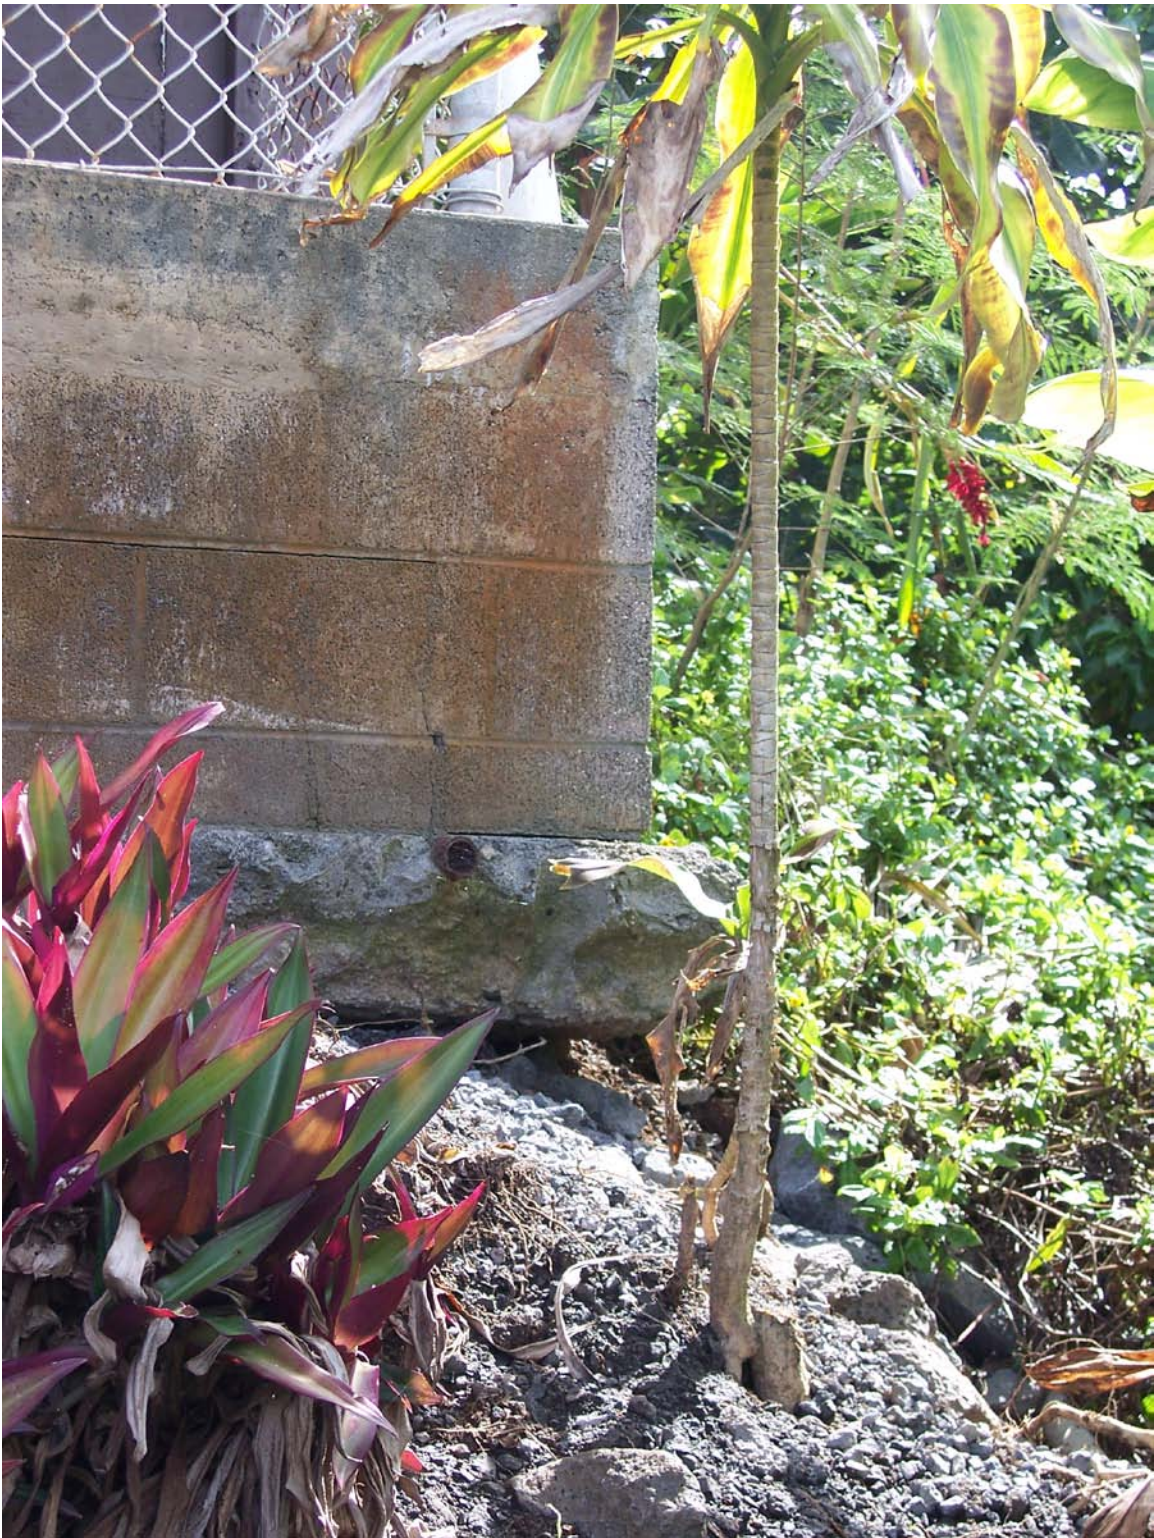
21.18. View of ground-slumping that undermined the concrete foundation of the corner of the pavilion (view to the south). USGS photo by T.J. Takahashi, 10/21/2006 (tjt1461).

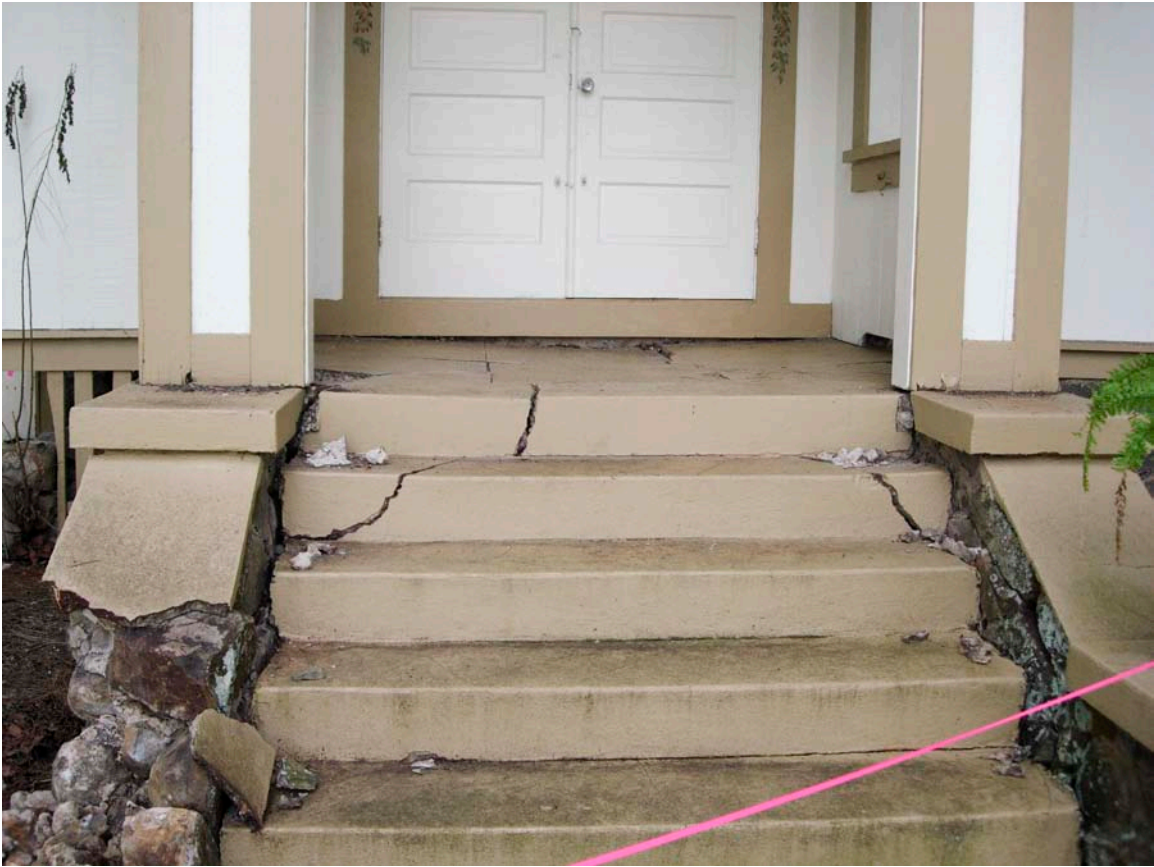
22.3. Detail of the collapsed stone-wall railing and cracks in the front steps and in the landing, which buckled from the shaking (view to the south). USGS photo by M.P. Poland, 10/19/2006 (mpp003).

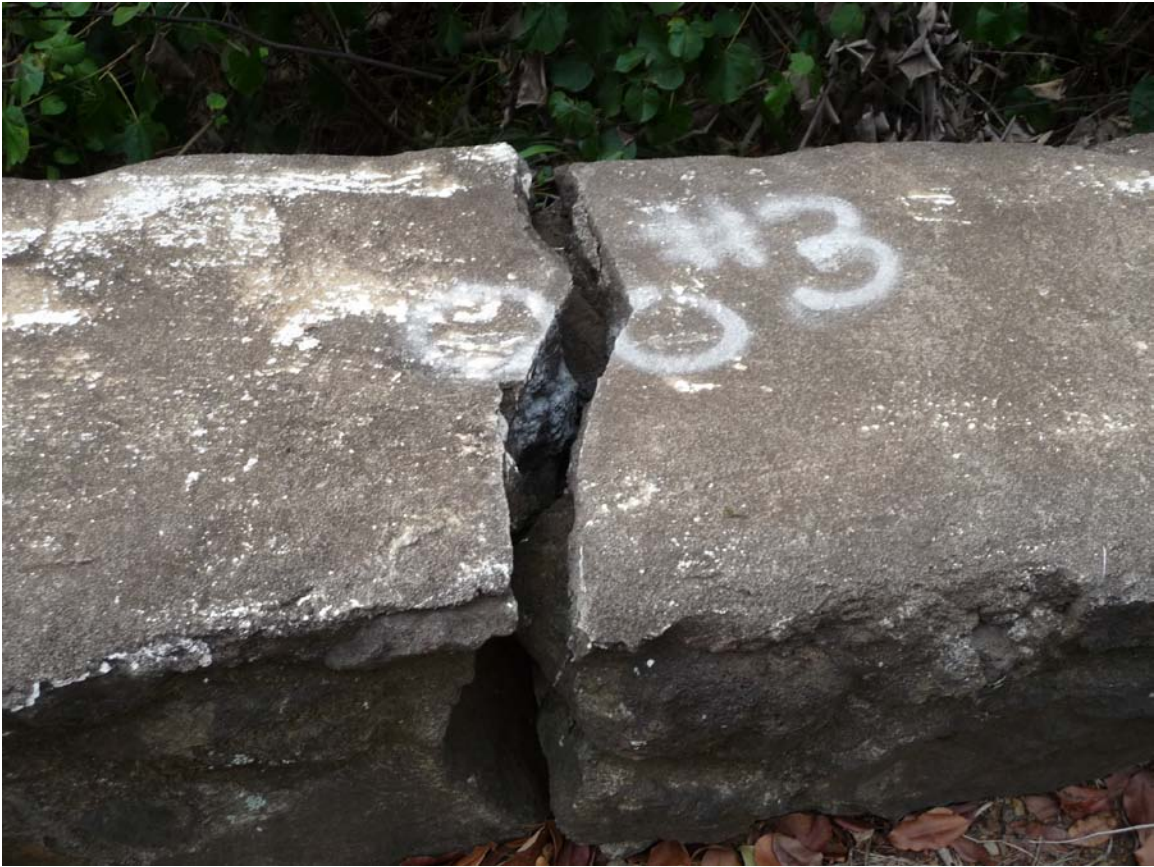
23.4. Close-up view of crack in the concrete guard wall at Pūwā‘ī‘ole Gulch (view to the northwest). USGS photo by N.A. Ikeda, 7/26/2008 (nai1023).

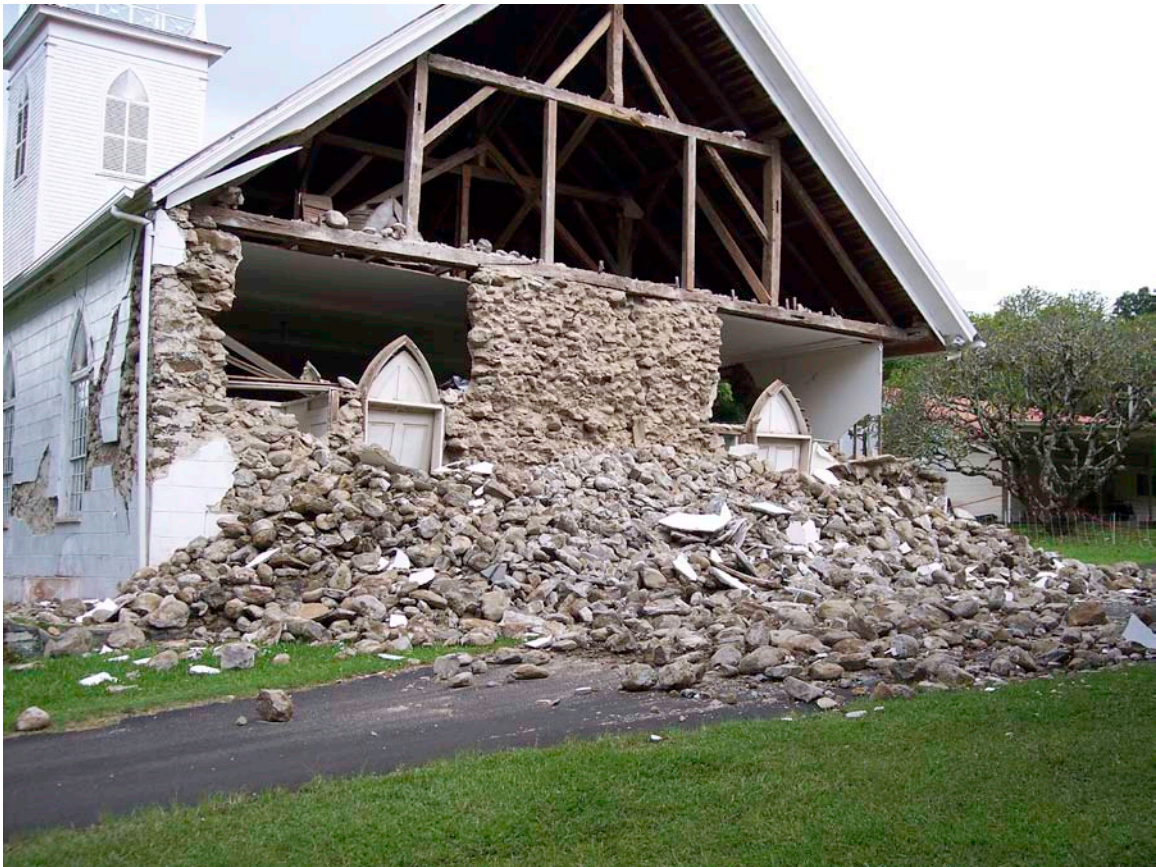
24.10. View of the church's front entrance, showing the collapsed wall under the eave, framing, and wall above the doors (view to the east-southeast). USGS photo by T.J. Takahashi, 10/20/2006 (tjt1371).
